Inspection report for the property at

235 Everyday St.

This report is prepared exclusively for **Roger Waters**  
Inspected On: **05-11-2026**

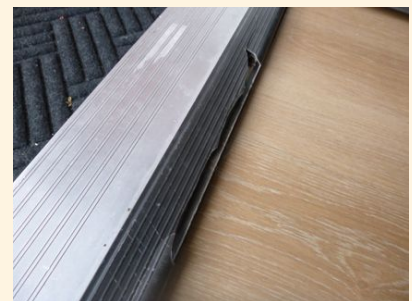
### 🔧 (E-1) Repair:

The weather stripping at the threshold of the front entry door is damaged. This should be repaired or replaced for added efficiency

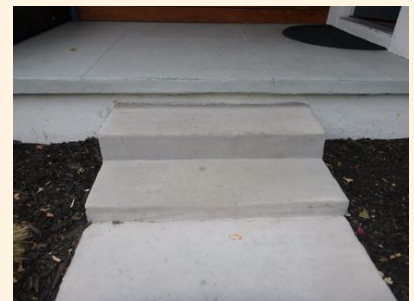
### (DPB-1) Repair:

The front concrete steps are non conforming. The difference in heights here could pose a hazard to foot traffic.

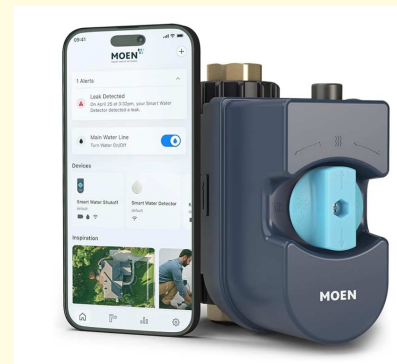
**CONSIDER A FLOW SENSOR ON THE MAIN WATER PIPE**

A [Flow water sensor](#) should be considered to protect the building. These are smart home technologies that can monitor the house for leaks and shut the water to the home off in case leaks are detected.

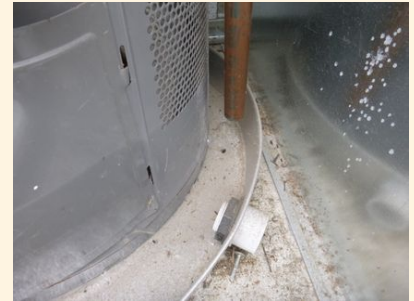
### (WH-1) Repair:

The [temperature and pressure relief valve](#) (TPRV) discharge tube for the water heater is terminating into a drain pan. This is not recommended (UPC). Ideally, the discharge tube for a relief valve:

- Terminates to an exterior location or above a drain, though this is not always possible
- Terminates between 6 and 24-inches off the ground (UPC)
- Slopes to drain to prevent water pooling inside the discharge tube
- Is not made from pipe with an inside diameter less than 3/4 on an inch
- Terminates to a visible location that can be monitored for leaks and discharges
- Does not have a threaded termination point which would prevent accidental capping of this important discharge
- Does not terminate into a drain pan

I recommend having this relief valve discharge tube further investigated and repaired as recommended by a licensed plumber.

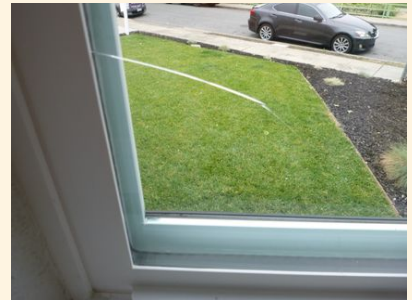
**(I-2) Repair:**

### CRACKED PANES OF GLASS NOTED

Cracked panes of glass were noted. This requires glazing replacement to repair. The following locations were noted: Front bedroom

Replace cracked panes of glass as needed.

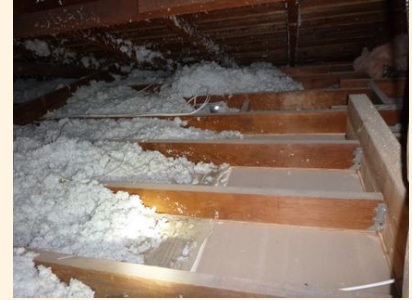
### ✂ (A-2) Repair:

The fiberglass insulation is uneven or missing in various areas. We recommend evening out the insulation for added efficiency

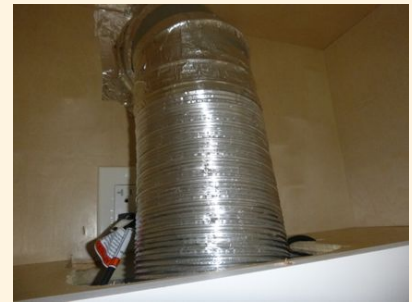
### ✂ (A-3) Repair:

#### **CORRUGATED KITCHEN EXHAUST VENT PIPE**

The kitchen fan duct is done using corrugated pipe. The kitchen fan vent pipe should be smooth wall only so it can be cleaned to prevent grease build-up which can be a fire hazard.
